**Flood Control Project Maintenance
Levee Inspections**
LMA District Cover Sheet
Spring 2018 Levee Inspection Results

Reclamation District No. 0784 Plumas Lake

Spring 2018 Levee Inspection Results

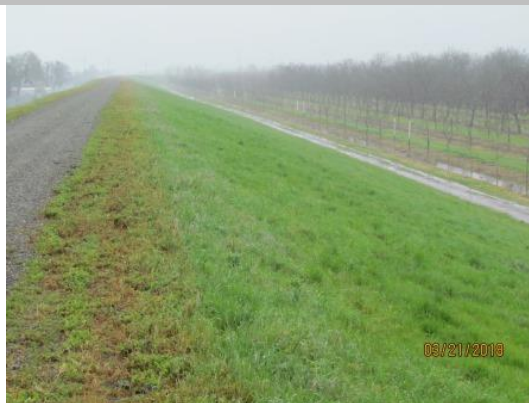
Photo 1 of 1 : SP_2018_RD0784_178_3_20180409_00007.jpg

View looking downstream waterside of the well maintained annual vegetation, Spring 2018.

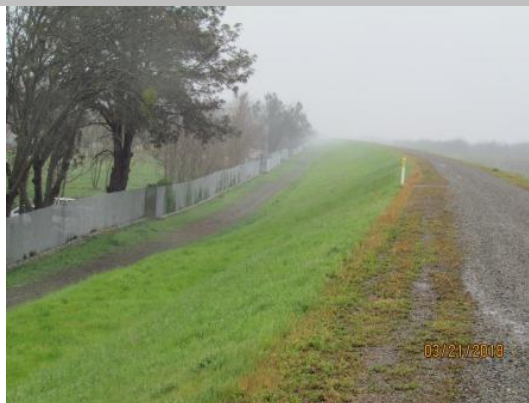
Photo 1 of 1 : SP_2018_RD0784_178_2_20180409_00008.jpg

LM Start	0.04	Rating **	A	Issue No.	2
LM End	2.20	Issue Type +	Ma	Location *	LS
Category	Earthen Levee			GPS Latitude/Longitude	
				Start	End
Item	Vegetation			39.134439 °	39.125908 °
				-121.552689 °	-121.588626 °
DWR ID	DWR_RD0784_01_s_2018_2				
Comment Code					
V1 : Control annual grass and weeds on the levee slopes and easements.					
Inspector Comment

View looking downstream landside of the well maintained annual vegetation, Spring 2018.

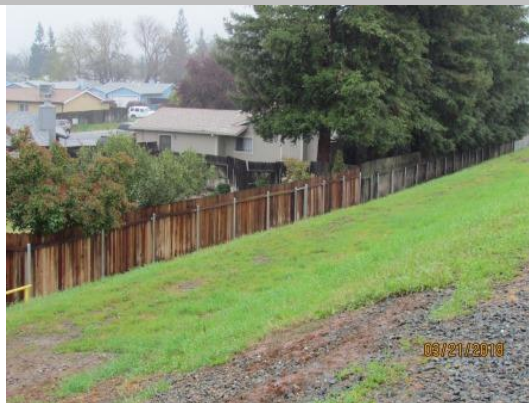
Photo 1 of 1 : SP_2018_RD0784_178_12_20180409_00009.jpg

LM Start	0.51	Rating **	U	Issue No.	12
LM End	1.00	Issue Type +	En	Location *	LS
Category	Earthen Levee			GPS Latitude/Longitude	
				Start	End
Item	Encroachments			39.131558 °	39.129475 °
				-121.560668 °	-121.569209 °
DWR ID	DWR_RD0784_01_f_2012_12				
Comment Code					
FE : Fence					
Inspector Comment					
Fences are found within the 10 feet of levee easement, Spring 2018.

View looking downstream landside of fences that are found on the landside toe of the levee looking downstream. Fall 2017.

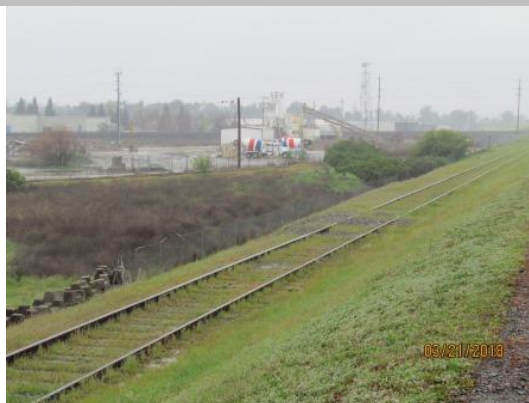
Photo 1 of 2 : SP_2018_RD0784_178_13_20180409_00010.jpg

LM Start	1.00	Rating **	M	Issue No.	13
LM End	1.12	Issue Type +	En	Location *	LS
Category	Earthen Levee			GPS Latitude/Longitude	
				Start	End
Item	Encroachments			39.129475 °	39.129615 °
				-121.569210 °	-121.571371 °
DWR ID	DWR_RD0784_01_f_2012_13				
Comment Code					
FE : Fence					
Inspector Comment					
Fence near the levee toe. Spring 2018.

View looking downstream landside of a fence near the levee toe, Spring 2018.

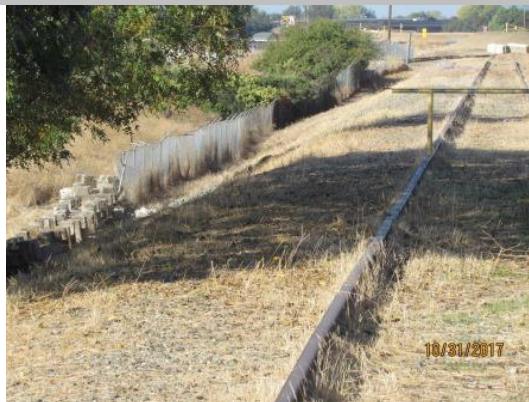
Photo 2 of 2 : SP_2018_RD0784_178_13_20180302_00002.jpg

LM Start	1.00	Rating **	M	Issue No.	13 (cont)
LM End	1.12	Issue Type +	En	Location *	LS

View looking downstream landside of a fence near the levee toe, Fall 2017.

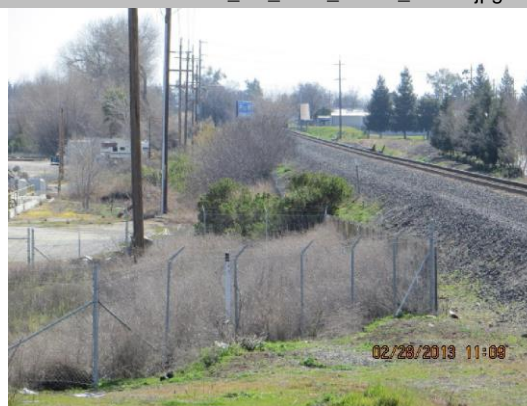
Photo 3 of 3 : UCIP_SP_2018_50677_54400.jpg

Comment Code						
Inspector Comment						
FS_ID:50677 DS_ID:18552 EP_NO: N/A Repair Type: Non-Urgent Crossing Status: Indicator Found UCIP Comments: 11/15/2016 - Crossing is still Non-Urgent due to the possibility that the pipe is unpermitted. The crossing will be downgraded when owner provides permit or CVFPB enforcement resolves the issue. (DWR UCIP - thatch)11/01/2015 - Letter requesting permit or to provide permit sent to owner Century Link, 700 W. Mineral Avenue, Rm D 27.34, Littleton, CO 80120 on 2/18/2014. Pending CVFPB enforcement on utility crossing owner. Requesting DWR inspector to change the status of this issue to "No Action Needed" (P. Meagher - RD784) 02/28/2013 - No permit identified for this crossing. Need to determine if owner has permit. (W.Wylie UCIP Inspector). FIELD_STRUCT_DESC: Fiber optics communications lines of an unknown material and diameter through the levee, at an unknown depth. [Additional Reference(s): DWR Levee Log, 2005]. FS Date: 9/11/2015 9:08:00 AM

Marker on East side of Rail/LS of levee.

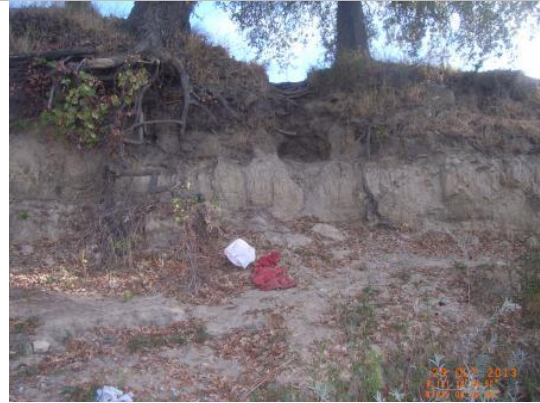
Photo 1 of 1 : SP_2018_RD0784_532_1_20180302_00001.jpg

Comment Code					
Inspector Comment					
2003 - Bank is near vertical. Identified as a Potentially Critical site. 2004 - Eddy flow off downstream end of Modesto formation eroding the fluvial sediments. 2005 - Some new slumping. Actively eroding but berm width is greater than 50 ft. 2006 - Downgraded to regular erosion site. Still actively eroding. Large old rotational failures in high bank on the downstream end. 2008 - Removed from inventory due to wide berm width does not meet criteria for an erosion site. 2010 - Added back to the inventory after 10 ft of bank erosion in the winter 2009 storm. Steep vertical face. 2011 - Bank has retreated an additional 2.5 ft from last year. New tree popouts and erosion throughout the site. 2012 - Site continues to worsen with new tree popouts and many sections of new erosion. 2015: Last observed in 2013. [2015 Site ID: FHR_17-8_L]

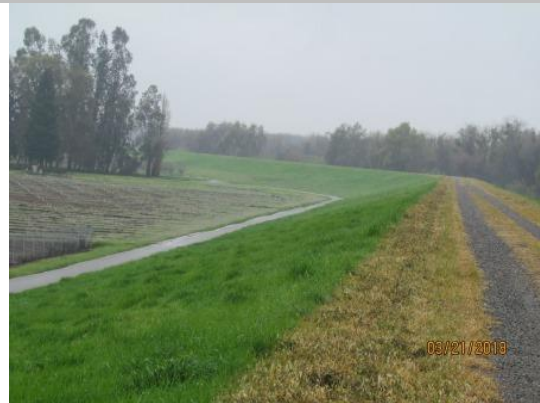
Photo 1 of 1 : SP_2018_RD0784_532_2_20180409_00007.jpg

LM Start	8.97	Rating **	A	Issue No.	2
LM End	12.85	Issue Type +	Ma	Location *	LS
Category	Earthen Levee			GPS Latitude/Longitude	
				Start	End
Item	Vegetation			39.009879 °	38.954721 °
				-121.579154 °	-121.574747 °
DWR ID	DWR_RD0784_02B_s_2018_2				
Comment Code					
V1 : Control annual grass and weeds on the levee slopes and easements.					
Inspector Comment					
Annual vegetation is well maintained, Spring 2018.

View looking downstream landside of the well maintained annual vegetation, Spring 2018.

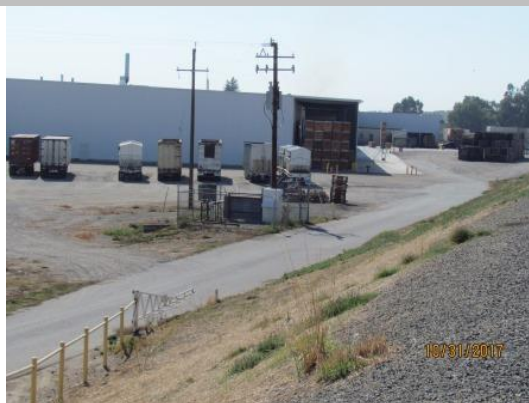
Photo 1 of 1 : SP_2018_RD0784_532_6_20180302_00002.jpg

LM Start	9.21	Rating **	M	Issue No.	6
LM End	9.31	Issue Type +	En	Location *	LS
Category	Earthen Levee			GPS Latitude/Longitude	
				Start	End
Item	Encroachments			39.006523 °	39.005235 °
				-121.577843 °	-121.578286 °
DWR ID	DWR_RD0784_02_f_2012_6				
Comment Code					
MA : Material					
Inspector Comment					
Un-permitted paving at levee toe. Fall 2017.

View looking downstream on the land side of un-permitted paving. Fall 2017.

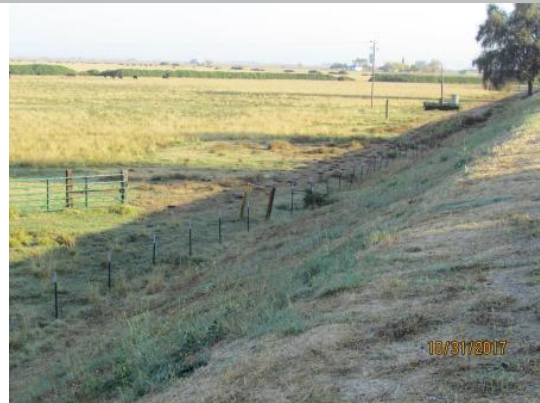
Photo 1 of 1 : SP_2018_RD0784_534_7_20180302_00001.jpg

LM Start	3.52	Rating **	A/W	Issue No.	8	
LM End	3.52	Issue Type +	Ma	Location *		
Category	Supplemental			GPS Latitude/Longitude		
				Start	End	
Item	DWR UCIP LMA Responsibility			38.974330 °	38.974330 °	
				-121.526799 °	-121.526799 °	
DWR ID						
Comment Code						
Inspector Comment						
FS_ID:51706						
DS_ID:18580						
EP_NO: N/A						
Repair Type: No Action Needed						
Crossing Status: Found						
UCIP Comments:						
FIELD_STRUCT_DESC: 30-inch corrugated metal drainage pipe						
through the levee, 19 feet below the crown. Flap gate on the waterside						
(WS) end. Concrete headwall at the WS toe. [Additional Reference(s):						
DWR Levee Log, 2005. USACE Sacramento O&M Manual 145, August						
1955 (Station 92+88)].						
FS Date: 2/27/2013

View looking upstream landside of a fence that is at the levee toe, Fall 2017.

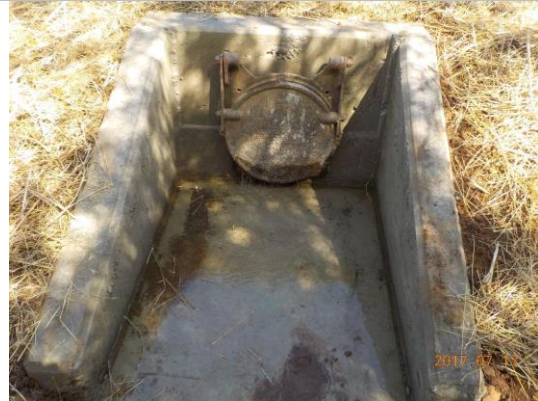
Photo 2 of 3 : UCIP_SP_2018_52571_77115.jpg

FS_ID:52571
DS_ID:18627
EP_NO: N/A
Repair Type: Urgent
Crossing Status: Found
UCIP Comments: 11/30/2017 Crossing remains Urgent due to uncertainty of pipe condition through levee -- recommend an internal inspection of the pipe through the levee as a precaution measure to determine integrity of pipe. Repair of the rusted out collar (void) found at the WS pipe outlet has been repaired by the LMA. Received additional photos from DWR levee inspector, S. York, of the WS concrete headwall installed and vegetation cleared from WS. (O. Magana - DWR UCIP)07/13/2017 - The rusted out collar at the bottom of the waterside flap gate has been sealed with concrete. Internal pipe inspections still pending. (P.Meagher-RD784).04/13/2017 - Spoke to LMA representative, P. Meagher, regarding the status of this crossing. The report has been updated to indicate vegetation has been cleared from WS outlet and LS inlet. The crossing remains Urgent--WS pipe collar is rusted out on the bottom. Recommend internal pipe inspection to determine pipe integrity through the levee. Owner will need to coordinate with the CVFPB to address issue. (O. Magana - DWR UCIP)

01/16/2017 - Landowner who utilizes this pipe reported to RD784 staff on 1/11/2017 that he suspected this pipe at the waterside flap gate ring area was rusted out at the bottom. After investigating, we could see what was reported is correct. Sandbags have been temporarily placed around the 2" +/- gapped area underneath the flap gate ring. A permanent solution is anticipated to be completed in the next 3 to 6 months. The plan is to pour a concrete ring / headwall around the open corroded pipe end. Photos attached. (P. Meagher - RD784).11/04/2016 - Flap gate on waterside has been cleared again as of 10/17/2016. The LS inlet area has been cleared as of 9/21/2016. See updated photos attached. (P.Meagher - RD784)09/22/2016 - vegetation at inlet of pipe has been cleared by owner. photos added showing pipe inlet. (T. Hatch - DWR UCIP)08/09/2016 - vegetation partially obscuring outlet on WS. Heavy vegetation on landside (LS) limiting inspection of inlet. Owner asked by RD0784 to clear vegetation and debris. (T. Hatch - DWR UCIP)11/1/2015 - Flap Gate has been cleared as of 12/9/2014 and again during summer of 2015 (P. Meagher/RD0784)2/27/2013 - Flap gate blocked by vegetation on WS toe. Unable to locate inlet. (W. Wylie - DWR UCIP)

Concrete collar completed around the waterside exterior flap gate section.

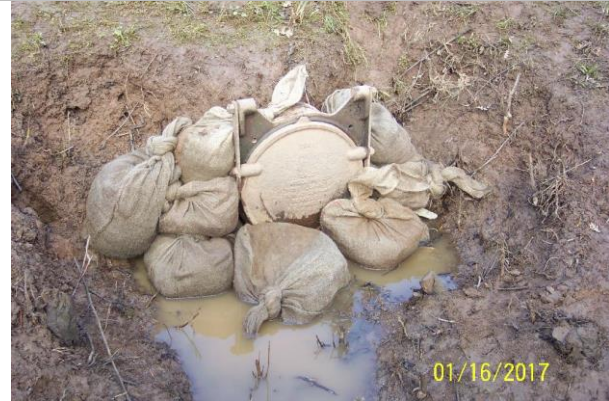
Photo 3 of 3 : UCIP_SP_2018_52571_76618.jpg

UCIP Comments: 11/30/2017 Crossing remains Urgent due to uncertainty of pipe condition through levee -- recommend an internal inspection of the pipe through the levee as a precaution measure to determine integrity of pipe. Repair of the rusted out collar (void) found at the WS pipe outlet has been repaired by the LMA. Received additional photos from DWR levee inspector, S. York, of the WS concrete headwall installed and vegetation cleared from WS. (O. Magana - DWR UCIP)07/13/2017 - The rusted out collar at the bottom of the waterside flap gate has been sealed with concrete. Internal pipe inspections still pending. (P.Meagher-RD784).04/13/2017 - Spoke to LMA representative, P. Meagher, regarding the status of this crossing. The report has been updated to indicate vegetation has been cleared from WS outlet and LS inlet. The crossing remains Urgent--WS pipe collar is rusted out on the bottom. Recommend internal pipe inspection to determine pipe integrity through the levee. Owner will need to coordinate with the CVFPB to address issue. (O. Magana - DWR UCIP)

01/16/2017 - Landowner who utilizes this pipe reported to RD784 staff on 1/11/2017 that he suspected this pipe at the waterside flap gate ring area was rusted out at the bottom. After investigating, we could see what was reported is correct. Sandbags have been temporarily placed around the 2" +/- gapped area underneath the flap gate ring. A permanent solution is anticipated to be completed in the next 3 to 6 months. The plan is to pour a concrete ring / headwall around the open corroded pipe end. Photos attached. (P. Meagher - RD784).11/04/2016 - Flap gate on waterside has been cleared again as of 10/17/2016. The LS inlet area has been cleared as of 9/21/2016. See updated photos attached. (P.Meagher - RD784)09/22/2016 - vegetation at inlet of pipe has been cleared by owner. photos added showing pipe inlet. (T. Hatch - DWR UCIP)08/09/2016 - vegetation partially obscuring outlet on WS. Heavy vegetation on landside (LS) limiting inspection of inlet. Owner asked by RD0784 to clear vegetation and debris. (T. Hatch - DWR UCIP)11/1/2015 - Flap Gate has been cleared as of 12/9/2014 and again during summer of 2015 (P. Meagher/RD0784)2/27/2013 - Flap gate blocked by vegetation on WS toe. Unable to locate inlet. (W. Wylie - DWR UCIP)

Sandbags temporarily placed in front of flapgate.

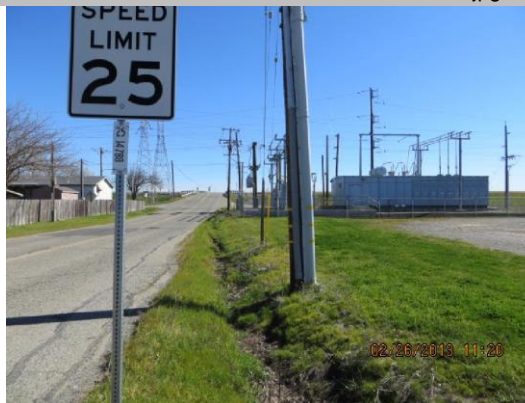
Photo 2 of 3 : UCIP_SP_2018_46600_54243.jpg

Communication line runs on south side of Plumas Arboga Road to JP approximately 400-feet West of levee crown.

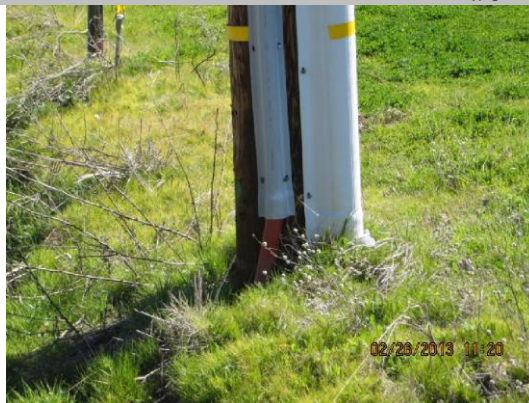
Photo 3 of 3 : UCIP_SP_2018_46600_54242.jpg

LM Start	3.59	Rating **	M	Issue No.	4 (cont)	
LM End	3.59	Issue Type +	En	Location *		
Category	Supplemental			GPS Latitude/Longitude		
				Start	End	
Item	DWR UCIP Field Study			39.026347 °	39.026347 °	
				-121.542343 °	-121.542343 °	
DWR ID						
Comment Code						
Inspector Comment						
FS_ID:46600						
DS_ID:22686						
EP_NO: N/A						
Repair Type: Non-Urgent						
Crossing Status: Found						
UCIP Comments: No permit identified for crossing.						
FIELD_STRUCT_DESC: Communications cable of an unknown material and diameter through the levee, at an unknown depth, on the downstream side of the bridge. [Additional Reference(s): USACE Sacramento O&M Manual 145, August 1955, (Station 132+40), listed as an 18-inch pipe].						
FS Date: 9/11/2015 9:25:57 AM

Communication line runs on south side of Plumas Arboga Road to JP approximately 400-feet West of levee crown.

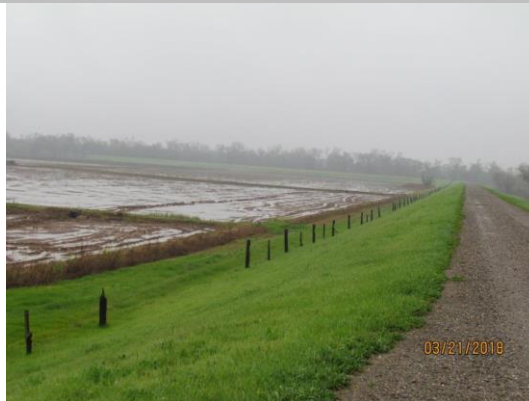
Photo 1 of 1 : SP_2018_RD0784_182_16_20180409_00035.jpg

View looking downstream landside of old fence post that need to be removed, Spring 2018.

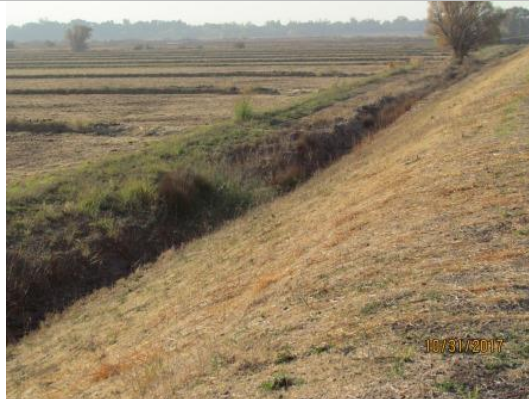
Photo 1 of 2 : SP_2018_RD0784_182_10_20180302_00005.jpg

View of landside looking downstream at the ditch that is along the levee toe. Fall 2017.

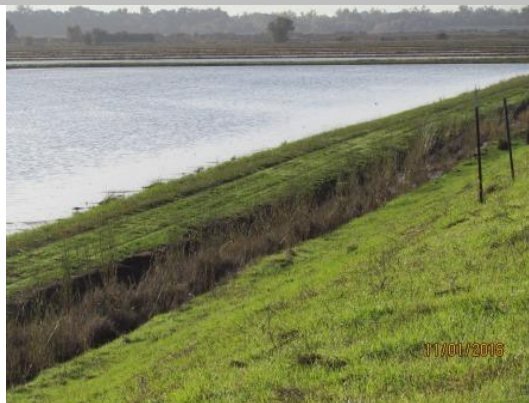
Photo 2 of 2 : SP_2018_RD0784_182_10_20180302_00006.jpg

View of landside looking downstream at the ditch that is along the levee toe. Fall 2016.

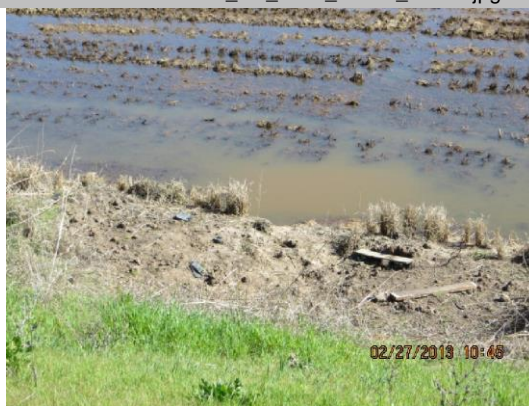
Photo 2 of 3 : UCIP_SP_2018_51719_54248.jpg

Debris covered inlet on LS toe.

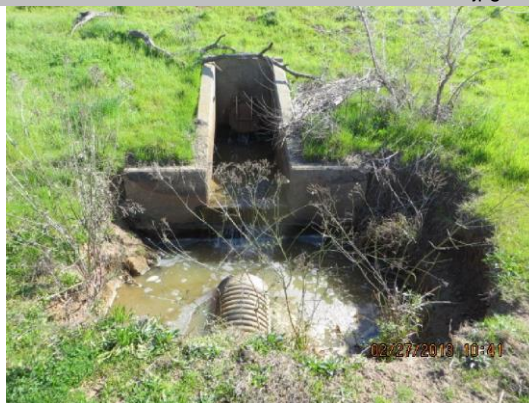
Photo 2 of 3 : UCIP_SP_2018_51707_54253.jpg

Concrete U-shaped headwall on WS toe with Flap gate showing erosion at outlet.

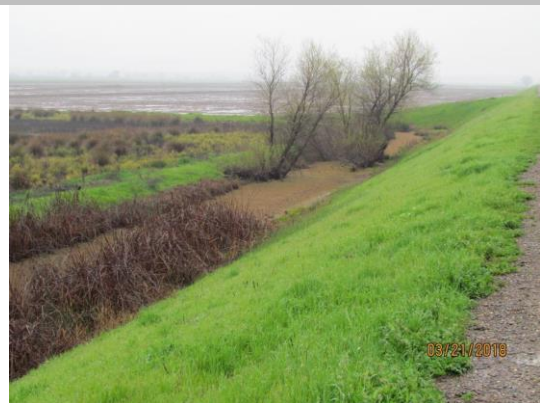
Photo 1 of 1 : SP_2018_RD0784_182_9_20180409_00040.jpg

View of landside looking downstream at the ditch that is along the levee toe, Spring 2018.

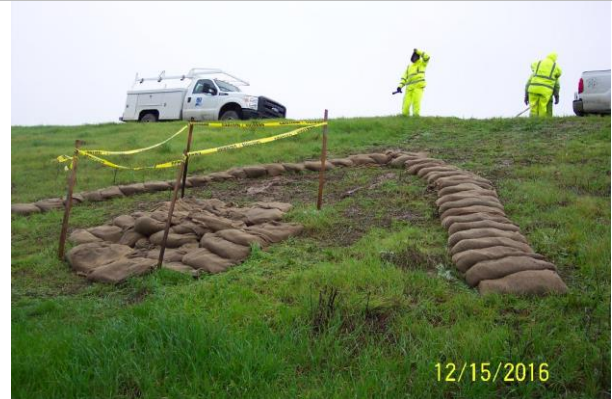
Photo 2 of 3 : UCIP_SP_2018_52570_76309.jpg

WS view: Sink hole filled in with sandbags and "V" shaped diversion dam built to help divert rainwater.

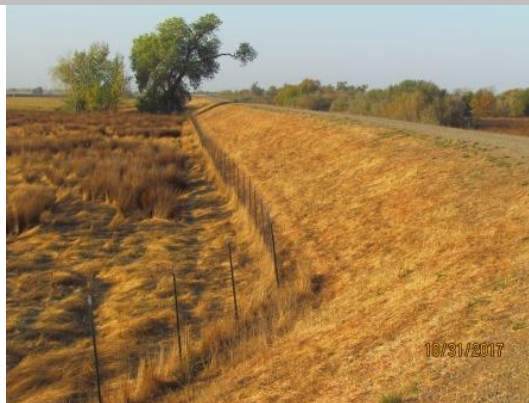
Photo 1 of 2 : SP_2018_RD0784_182_5_20180302_00001.jpg

View of fence along the landside toe looking downstream. Fall 2017.

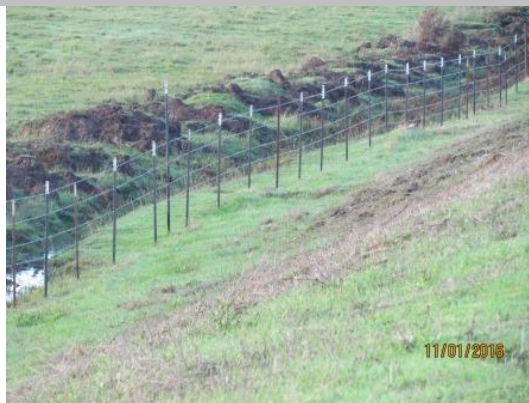
Photo 2 of 2 : SP_2018_RD0784_182_5_20180302_00002.jpg

View of fence along the landside toe looking downstream. Fall 2016.

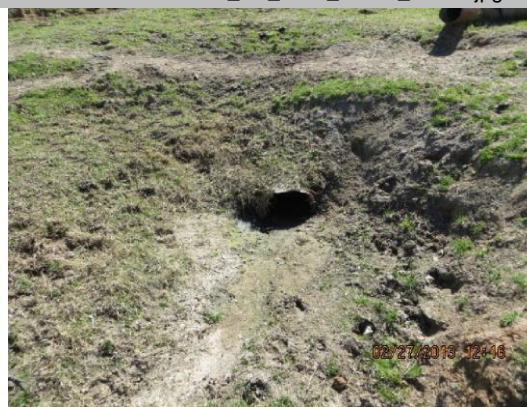
Photo 2 of 3 : UCIP_SP_2018_51716_54268.jpg

Partially clogged inlet pipe at LS toe.

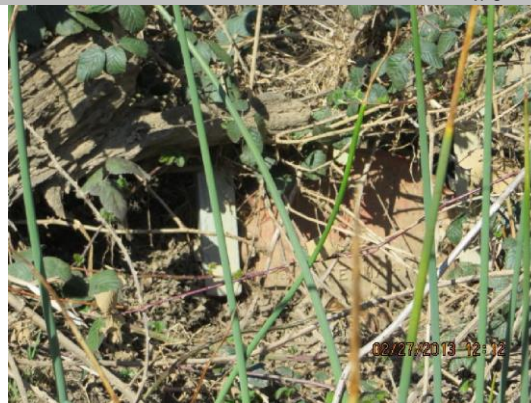
Photo 3 of 3 : UCIP_SP_2018_51716_54265.jpg

Flap gate blocked by vegetation at WS.
